CENTRAL INTELLIGENCE AGENCY

INFORMATION REPORT

Port Information: Stettin

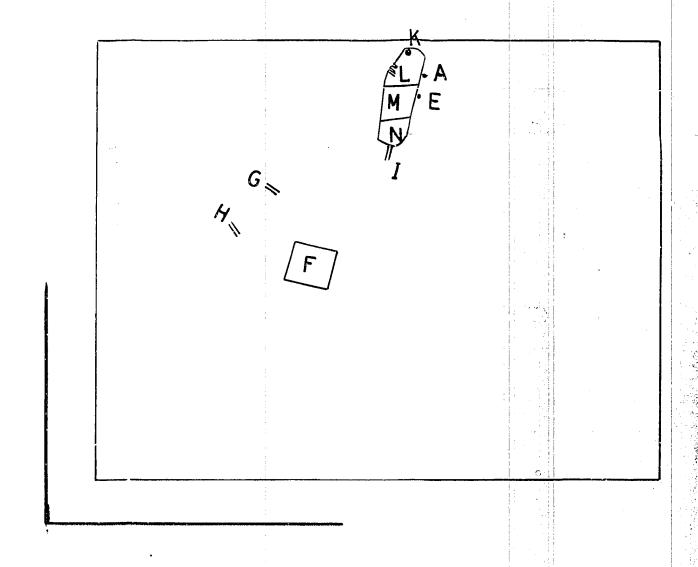
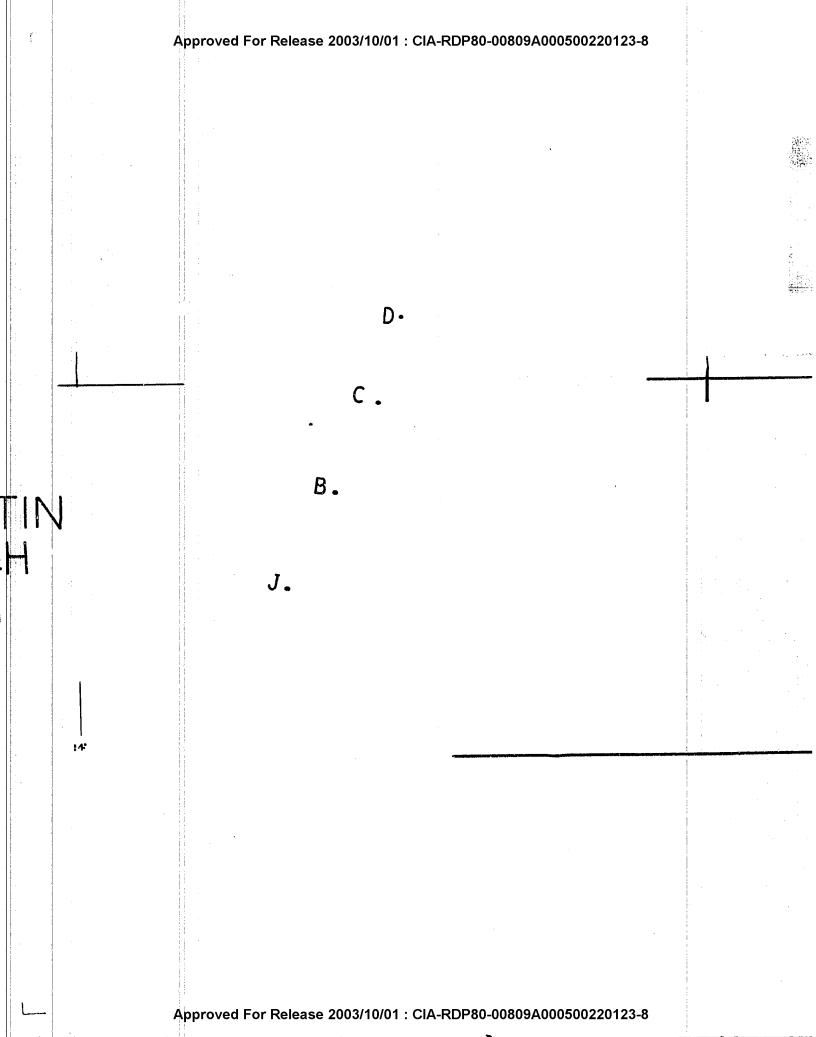
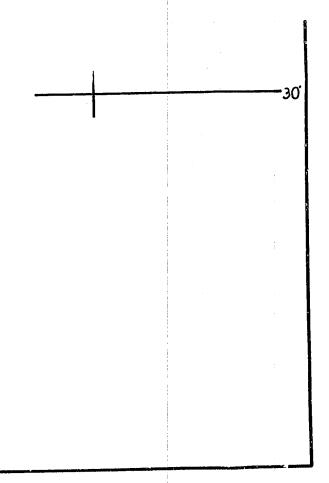
PORT STETTIN & APPROACH B.A-185

- A. Berthing location on arrival
 - B. Submarine Pen
 - C. Submarine Pen
 - D. Submarine Pen
 - E. Second berthing location
 - F. Coaling facility
 - G. Destroyed bridge replaced by Bailey Bridge

- H. Destroyed bridge replaced by Bailey Bridge
 - I. Temporary bridge of wooden construction
 - J. Shipyard
 - K. Grain silo
 - L. Czechoslovakian Quay Zone

- M. Polish Quay Zone N. Soviet Quay Zone
- 3. Source stated he saw nothing which would enable him to answer the specific questions contained in NIRM 18 unless the approximately 20 PT boats which are moored at B, C and D on overlay of reproduction of British Admiralty Chart No 185, along with various types of fishing vessels are so considered. These PT's were identified as being similar to the Vosper class. They were approximately 70' in length, appeared to be of Italian design, manned by Soviet sailors and armed with automatic weapons of from 25 to 50 caliber. U.S. Officials Only

- 12. The entire quay mentioned above is divided into three zones: the Czechoslovakian, Polish and Soviet, which are identified by indicators L, M and N on overlay to reproduction of British Admiralty Chart No 185, respectively. The quay is of atoms construction, has apron width of one thousand feet and 25 feet of water alongside.

- Source noted a newly completed coaling facility of considerable size at point F on overlay to reproduction of British Admiralty Chart No 185. He thought it to be less than two years old and similar to the one at Humpton Roads, Virginia; with inclined railway tracks where cars can discharge onto a moving conveyor belt system.
